Information on the Hazards of Aluminum Wiring and what it can mean to you.

Prepared For: Beacon Hill Civic Association
Naamans Road
Wilmington, DE 19810

Prepared By: Triton Electric
62F Southgate Boulevard
New Castle, DE 19720
302 326 2123-P
302 326 3714-F
Contact: Tom Kirk

Repairing Aluminum Wiring

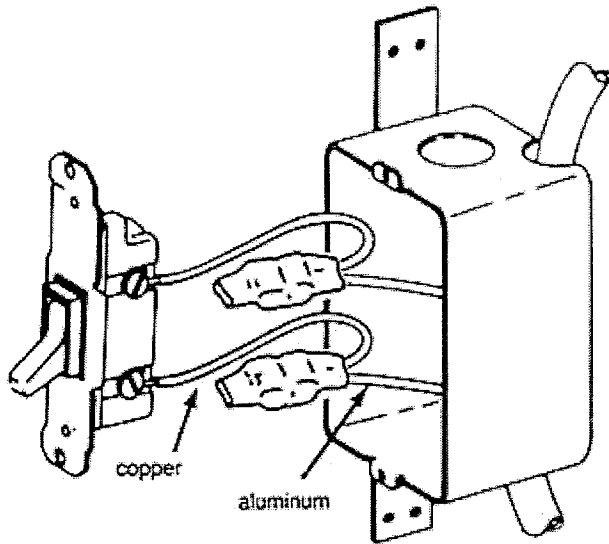
Reconnection for switch or duplex receptacle with AMP COPALUM Connectors.

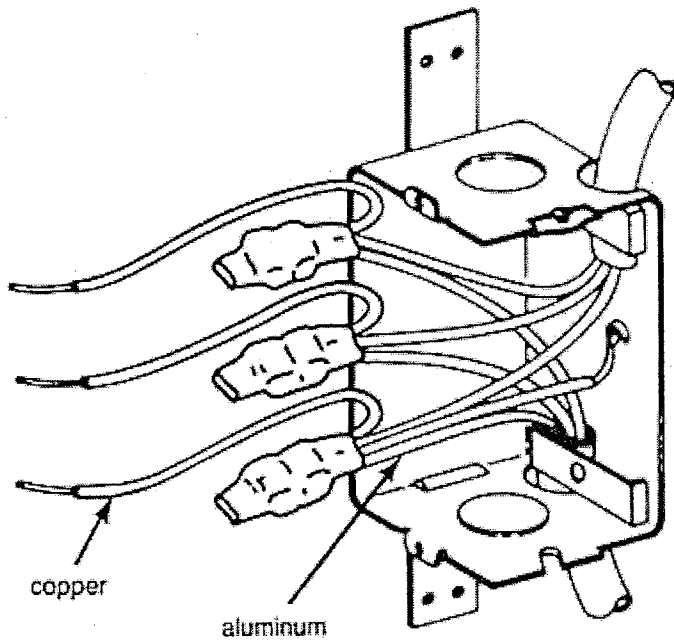
Reconnection for typical feed-through circuit with AMP COPALUM Connectors.

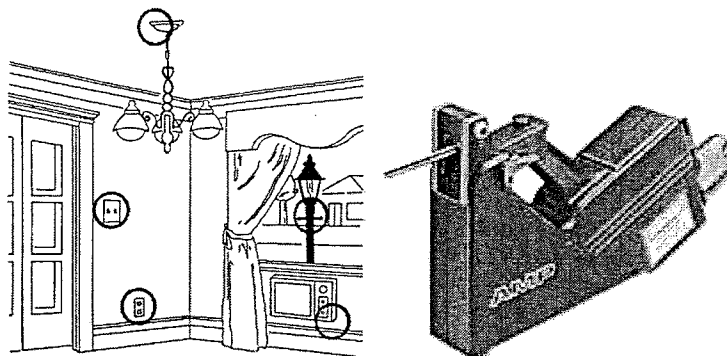
COPALUM Connectors and Heat Shrink Tubing System

COPALUM Connectors have copper body construction with a perforated copper alloy liner for solid 12, 14 AWG CU; and for solid 10, 12 AWG Al wire.

The application procedure is fast and efficient. The COPALUM Connector uses a perforated copper alloy liner for optimum mechanical and electrical performance. Using AMP tooling, the relatively soft, old technology aluminum conductor is forced into the perforated liner, allowing oxide-free aluminum to be brought into solid contact with the connector. AMP heat shrink tubing insulates the connection to complete the termination.

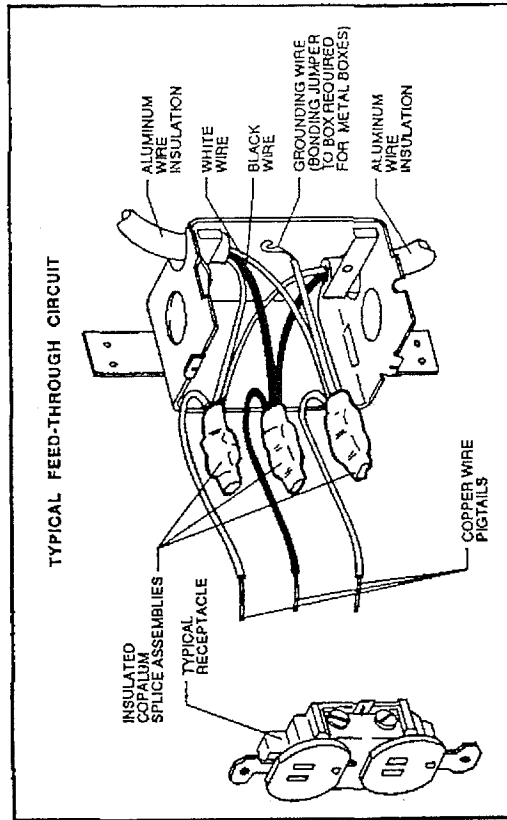
Recommended COPALUM Crimp Connector Repair

- ◆ The crimp connector repair consists of attaching a piece of copper wire to the existing aluminum wire branch circuit with a specially designed metal sleeve and powered crimping tool. The metal sleeve is called a COPALUM parallel splice connector and is manufactured only by AMP Incorporated. This special connector can be properly installed only with the matching AMP tool. This tool makes a permanent connection that is, in effect, a cold weld. An insulating sleeve is placed around the crimp connector to complete the repair.

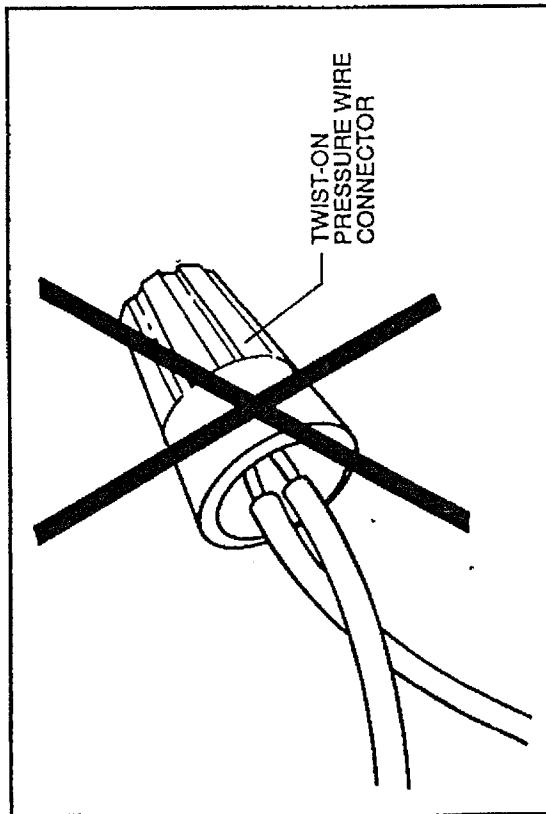
"Pigtail" Is Not a Recommended Repair

◆ The first repair ("pigtail") involves attaching a short piece of copper wire to the aluminum wire with a twist-on connector sometimes called a wire nut, the copper wire is connected to the switch, wall outlet or other termination device. The Commission staff has evaluated the effectiveness of "pigtail" as a repair. In CPSC-sponsored laboratory testing some brands of twist-on connectors have performed very poorly. Over time, substantial numbers of these connectors have overheated in laboratory tests. Surveys of and statements made by electricians and electrical inspectors confirm the highly variable and often poor performance of these connectors when used with old technology aluminum wire. It is possible that some pigtail "repairs" made with twist-on connectors may be even more prone to failure than the original aluminum wire connections. Accordingly, the Commission staff believes that this method of repair does not solve the problem of overheating present in aluminum branch circuits.

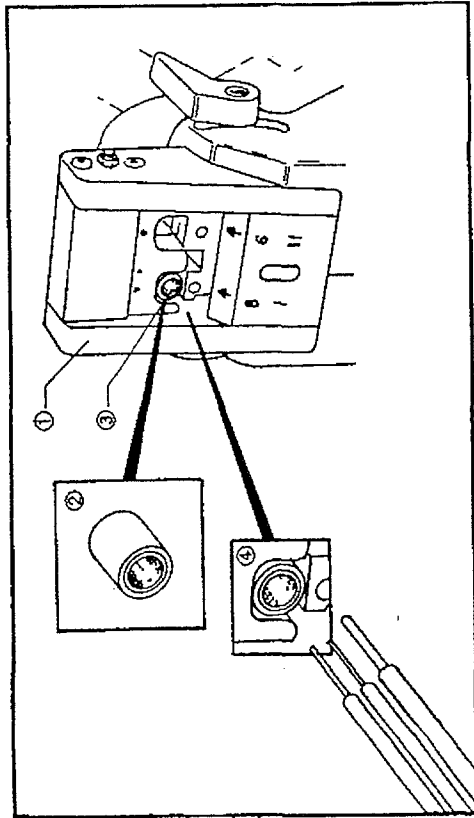
How the COPALUM Crimp Method Works

◆ The precision dies in the COPALUM tool squeeze the connector and wires into a particular shape which was determined during the design of the COPALUM wire connector. Both the final shape of the connection and the amount that it is squeezed (deformed during crimping) are critical in making a reliable crimp connection. Upwards of 10,000 pounds of force is necessary to obtain the amount of deformation for which the connector is designed.

- (1) Use the correct tool and dies (recommended by the AMP field representative) for the splice being crimped. Ensure that the color coding and marking designation on the splice correspond to the color coding and marking designation on the tool.
- (2) Be sure the perforated liner is inside the splice. The ends of the liner are flared to prevent removal.
- (3) Load the splice into the dies of the tool.
- (4) Insert stripped wires into the splice until the ends of wires extend beyond end of the splice. Wires should be parallel in the splice. Insulation of the wire MUST NOT ENTER the splice.
