**Beacon Hill Townhome Condominium
Wilmington, Delaware**

EXECUTIVE SUMMARY

At the direction of the Board that recognizes the need for proper reserve planning, we have conducted a *Precision 20/20 Full Reserve Study* of Beacon Hill Townhome Condominium (Beacon Hill) located in Wilmington, Delaware and submit our findings in this report. The effective date of this study is the date of our visual, noninvasive inspection, June 23, 2011. This Reserve Study is a budget planning tool that identifies the current status of the reserve fund and a stable and equitable Reserve Funding Plan to offset the anticipated future major common area expenditures.

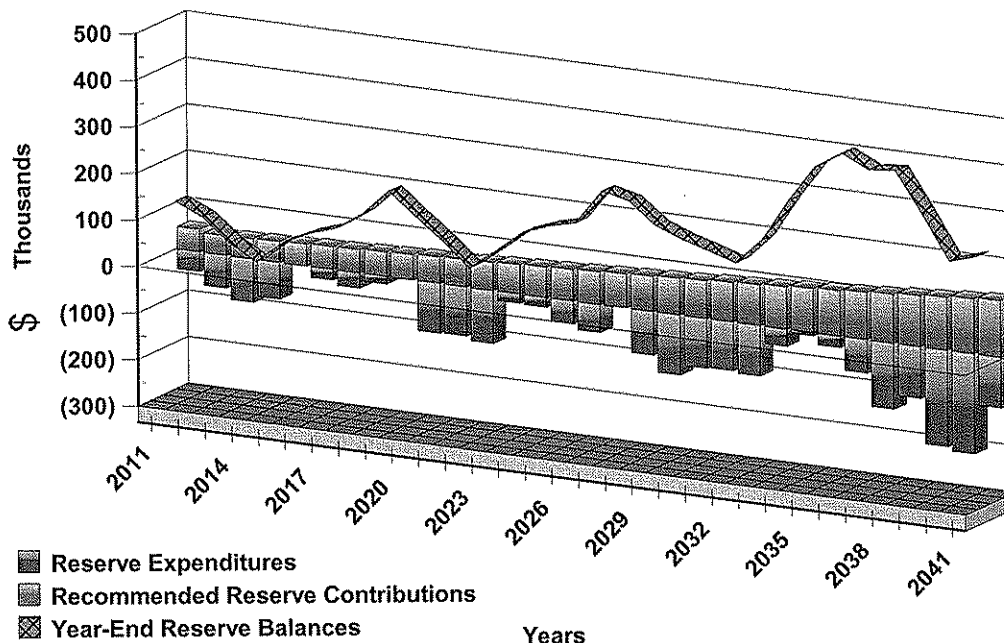
Recommended Reserve Funding Plan Beacon Hill Townhome Condominium

Based on the investigation and analysis as detailed in the accompanying narrative, we recommend the following Reserve Funding Plan (Reserve Contributions) to offset the anticipated future Reserve Expenditures of the subject Reserve Components during the next 30 years.

Exhibit C *Reserve Funding Graphs* contains two graphs and one pie chart. The graph Recommended Reserve Funding Plan shows the future fund balances based on the anticipated Reserve Expenditures and recommended annual Reserve Contributions during the next 30 years. The second graph Reserve Balances compares the recommended year end amounts of accumulated reserves with the potential shortage of reserves if the Association were to continue contributing to reserves at its current budgeted amount for the next 30 years. The pie chart Estimated Future Reserve Expenditures illustrates the relative importance of Reserve Expenditures and relative funding during the next 30 years.

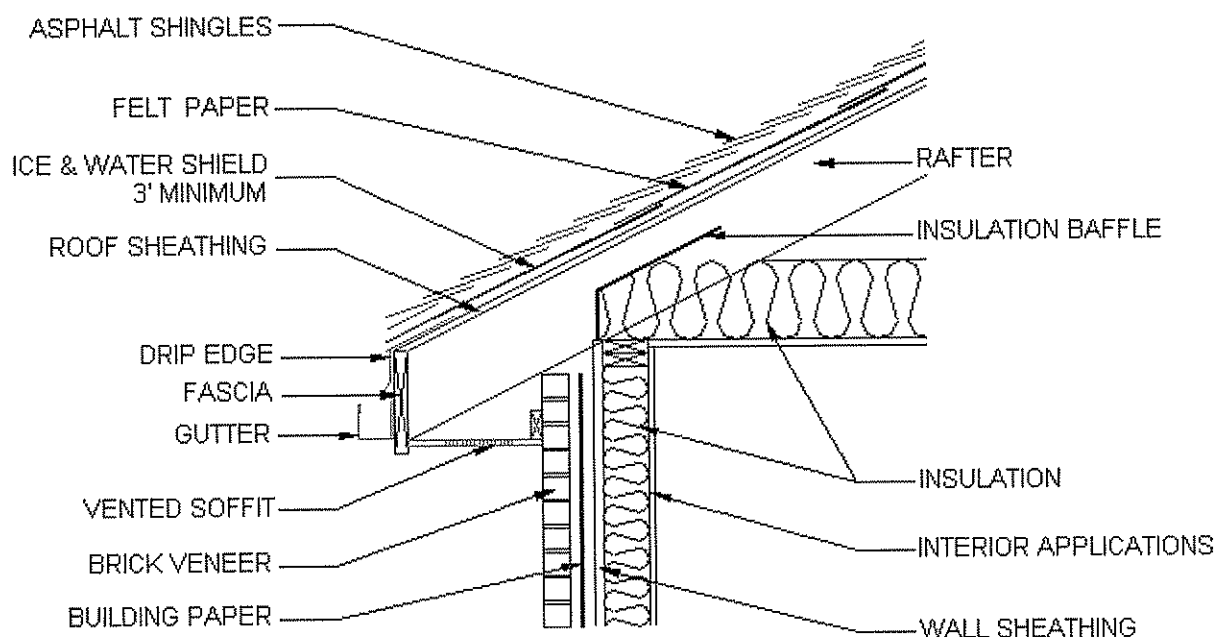
The *tear-off* method of replacement includes removal of the existing shingles, flashings if required and underlayments. The contractor should then inspect the roof sheathing for areas of water damage and partially replace the sheathing as needed. Once the roof sheathing is repaired, the contractor can begin installation of the new underlayments, flashings and shingles. The following cross-sectional schematic illustrates an asphalt shingle roof system.

The two types of underlayment most often used in an asphalt shingle roof system are ice and water shield membrane, and organic felt paper of varying weights depending on local building codes. Both types of underlayment protect the roof sheathing from moisture damage and wind-driven ice and snow. They have a low vapor resistance that impedes the accumulation of moisture between the underlayment and the roof sheathing. Ice and water shield membrane is thicker than organic paper and is used in areas that are subject to ice dams and standing water. The contractor should install ice and water shield membranes (often a modified bitumen product) at the outer 36 inches of the gutter and rake edge roof eaves, and in the roof valleys. Standard

15-pound organic felt paper should provide sufficient protection over the remaining portions of the roof. Underlayments work in conjunction with flashings to form a watertight roof system.

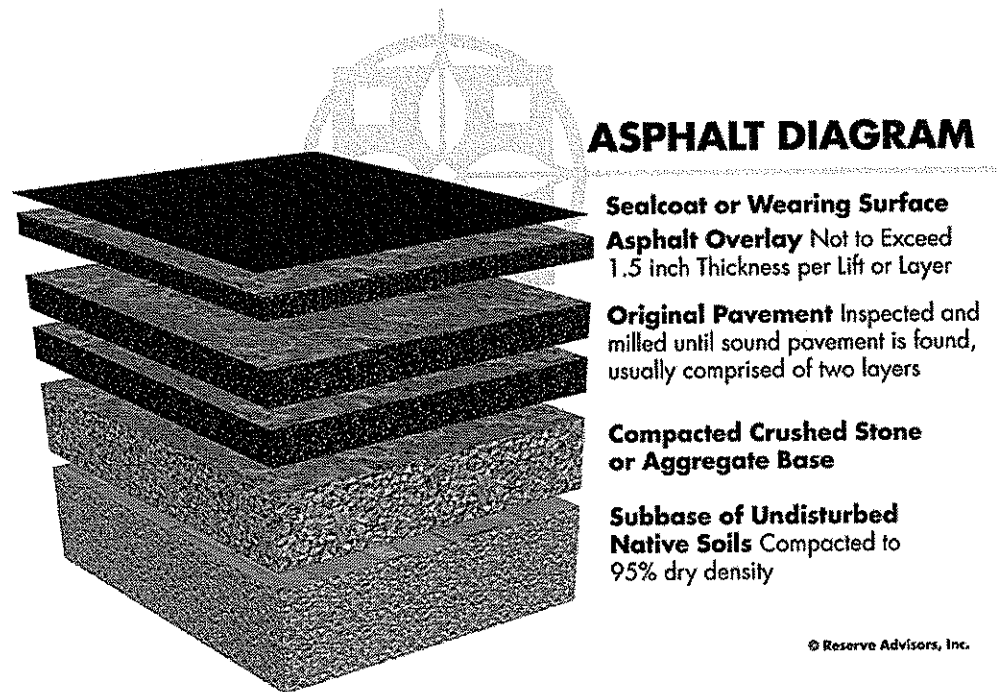
Components of asphalt pavement include native soil, aggregate and asphalt. First the contractor creates a base course of aggregate or crushed stone and native soil. The base course is individually compacted to ninety-five percent (95%) dry density prior to the application of the asphalt. Compaction assures a stable base for the asphalt that reduces the possibility of settlement. The initial installation of asphalt uses at least two lifts, or two separate applications of asphalt, over the base course. The first lift is the binder course. The second lift is the wearing course. The wearing course comprises a finer aggregate for a smoother more watertight finish. The following diagram depicts these components.

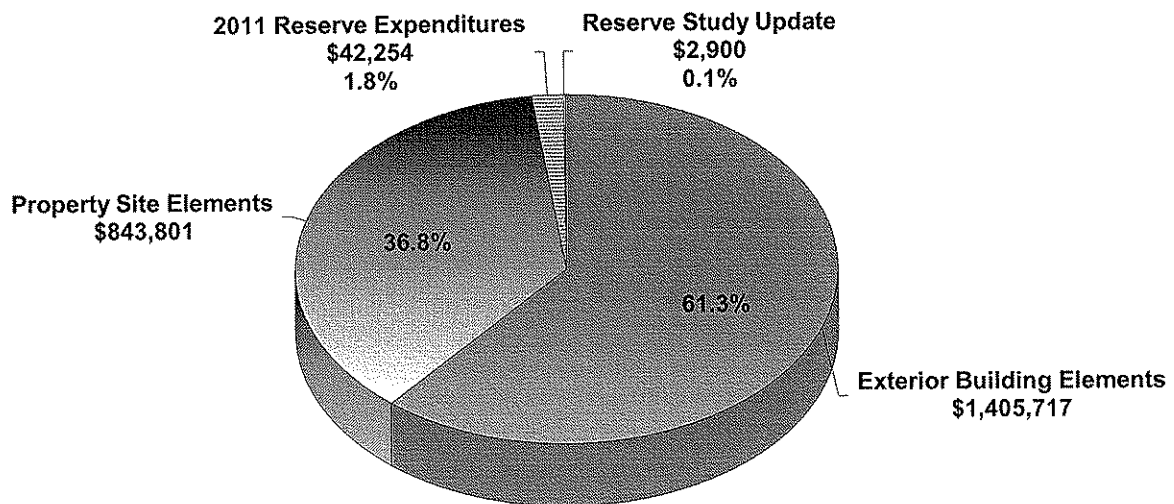
Future Expenditures Relative Cost Illustration Beacon Hill Townhome Condominium

The most important category of Reserve Components noted in **Exhibit B** *Reserve Expenditures* is the Exterior Building Elements. The following chart illustrates the relative importance of the Reserve Expenditures and relative funding during the next 30 years.

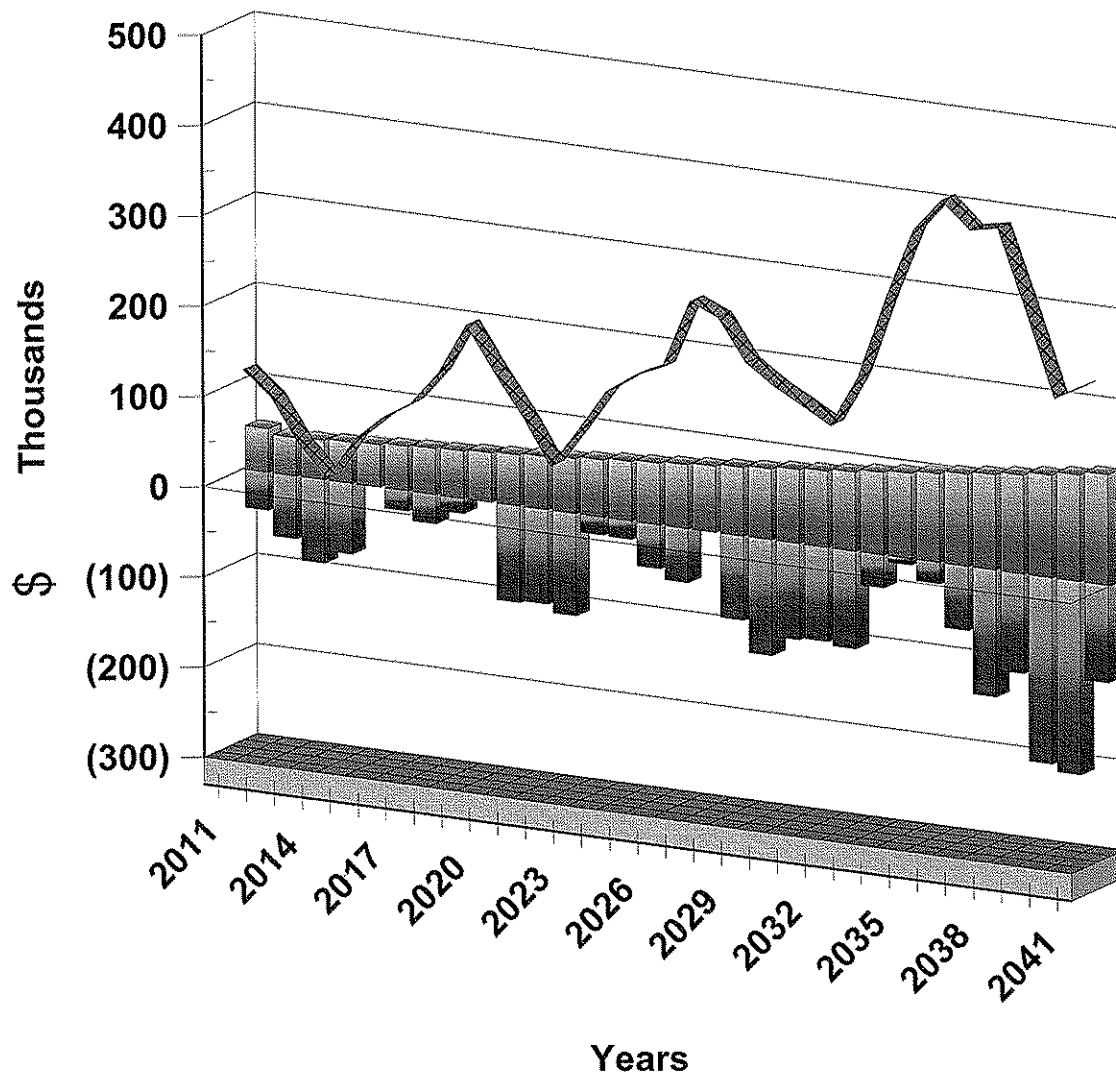
Recommended Reserve Funding Plan Beacon Hill Townhome Condominium

- Reserve Expenditures
- ▨ Recommended Reserve Contributions
- ▩ Year-End Reserve Balances

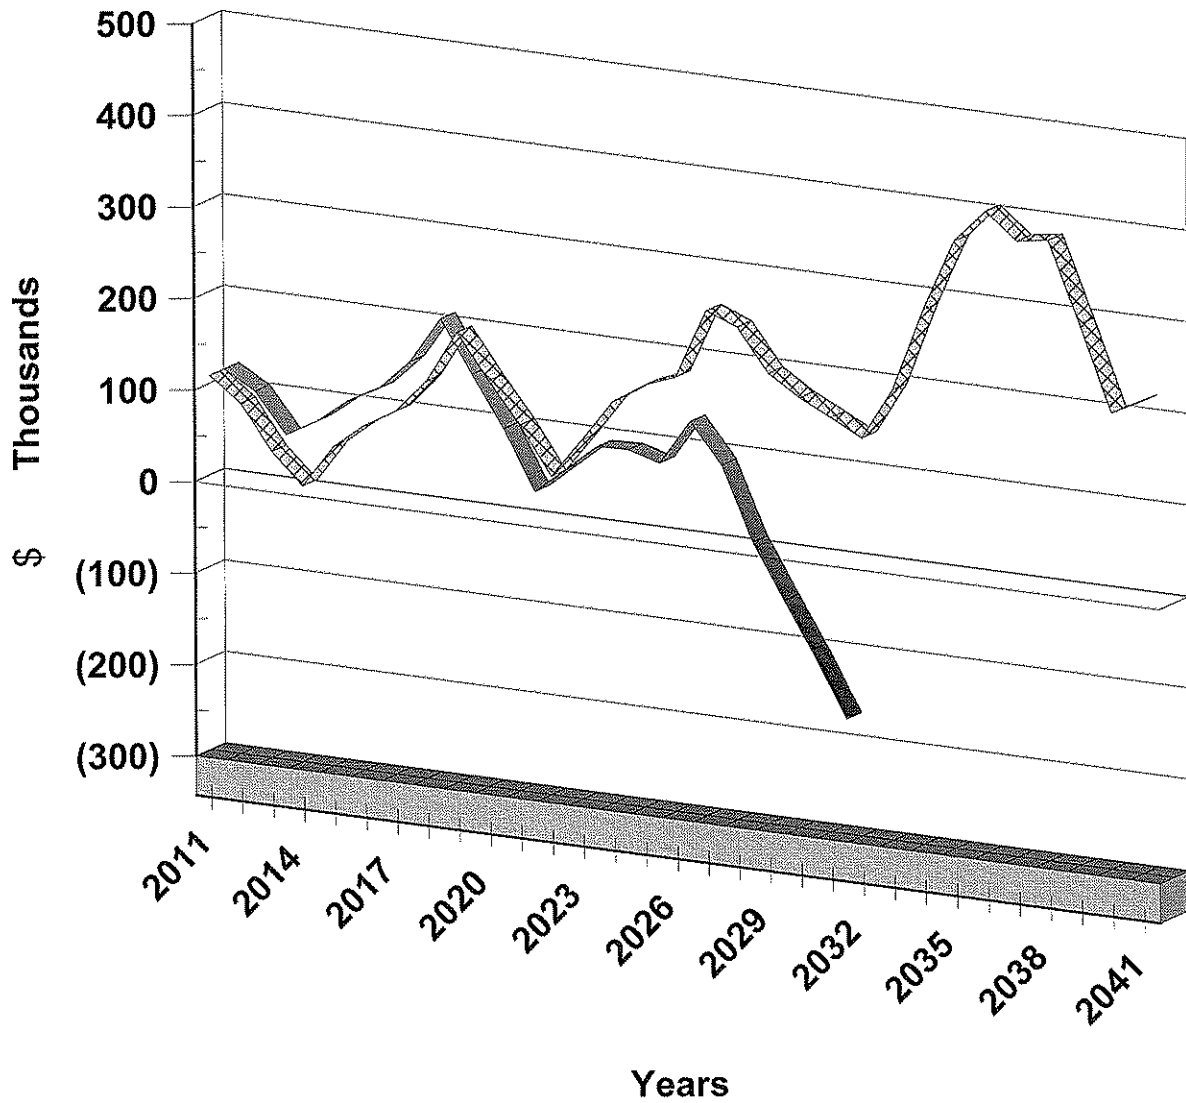
Reserve Balances Beacon Hill Townhome Condominium

Year-End Reserve Balances Using Recommended Funding

Potential Year-End Reserve Balances Using Historical Funding
